# Homer Hadley Floating Bridge 2007 Random Watertight Inspection

Transportation Commission Resolution 398

January 10, 2008

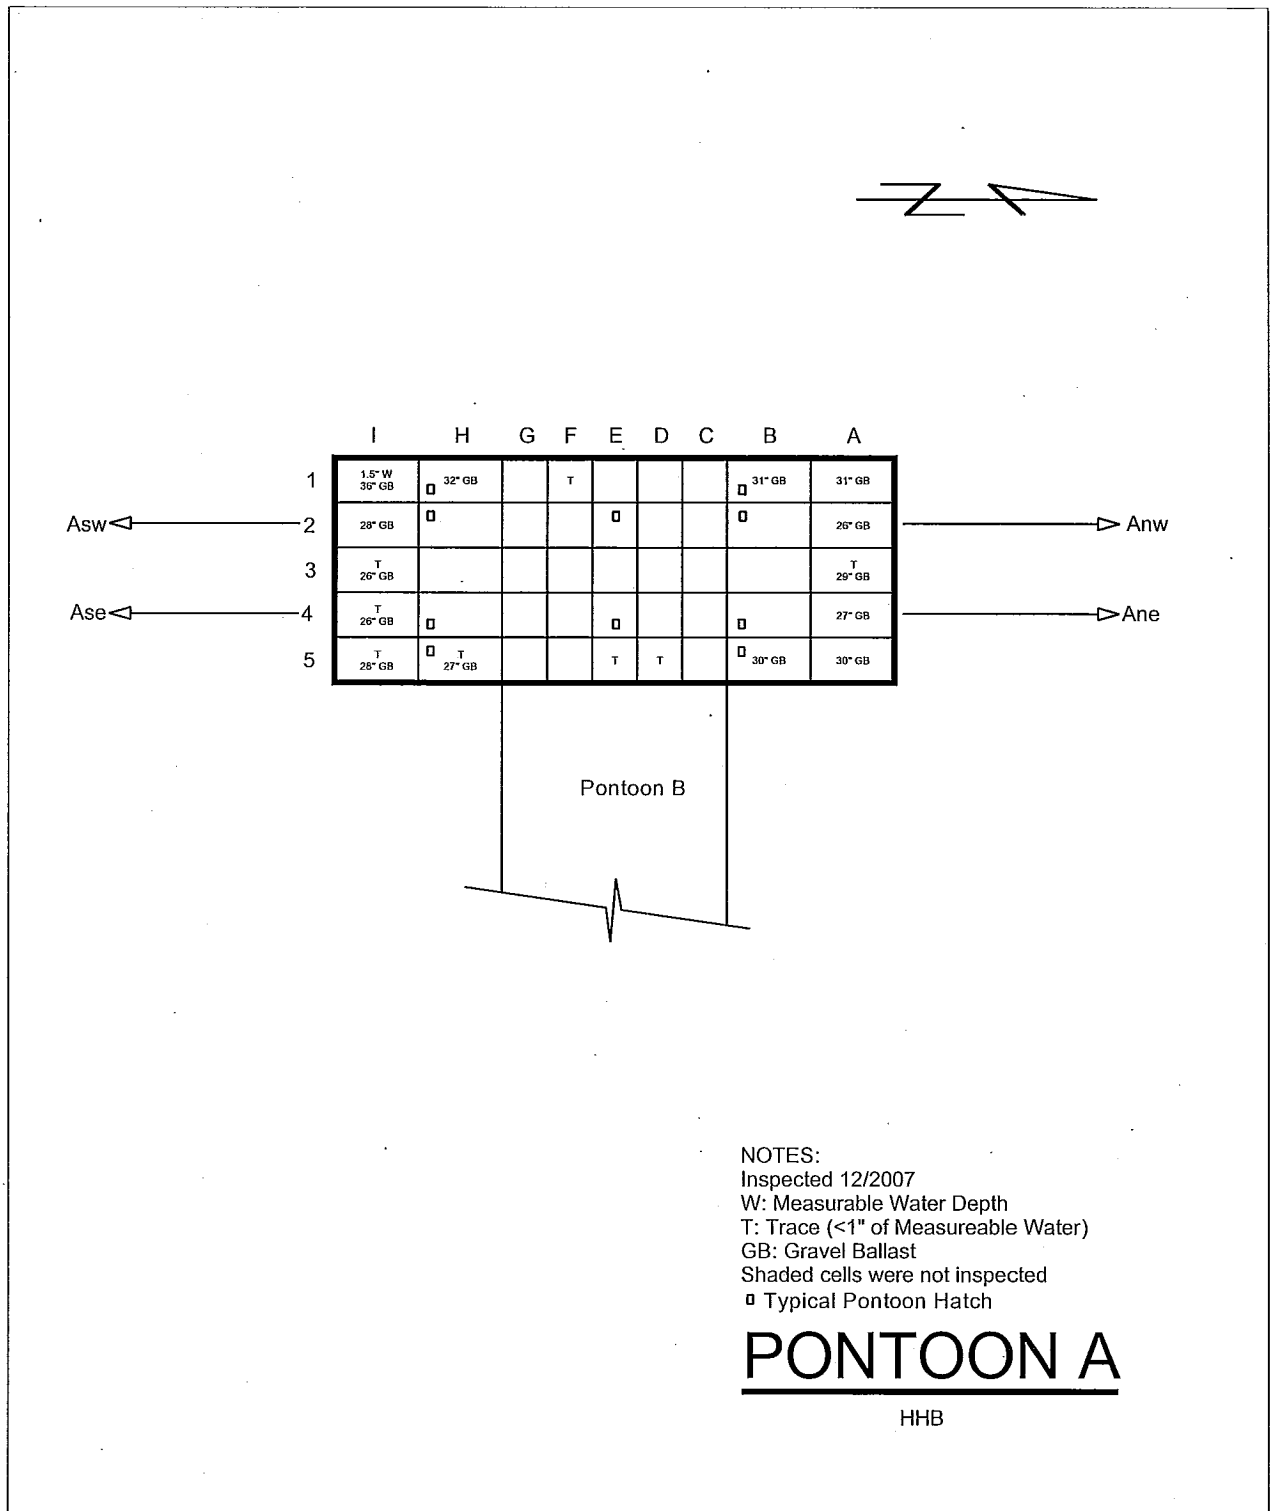
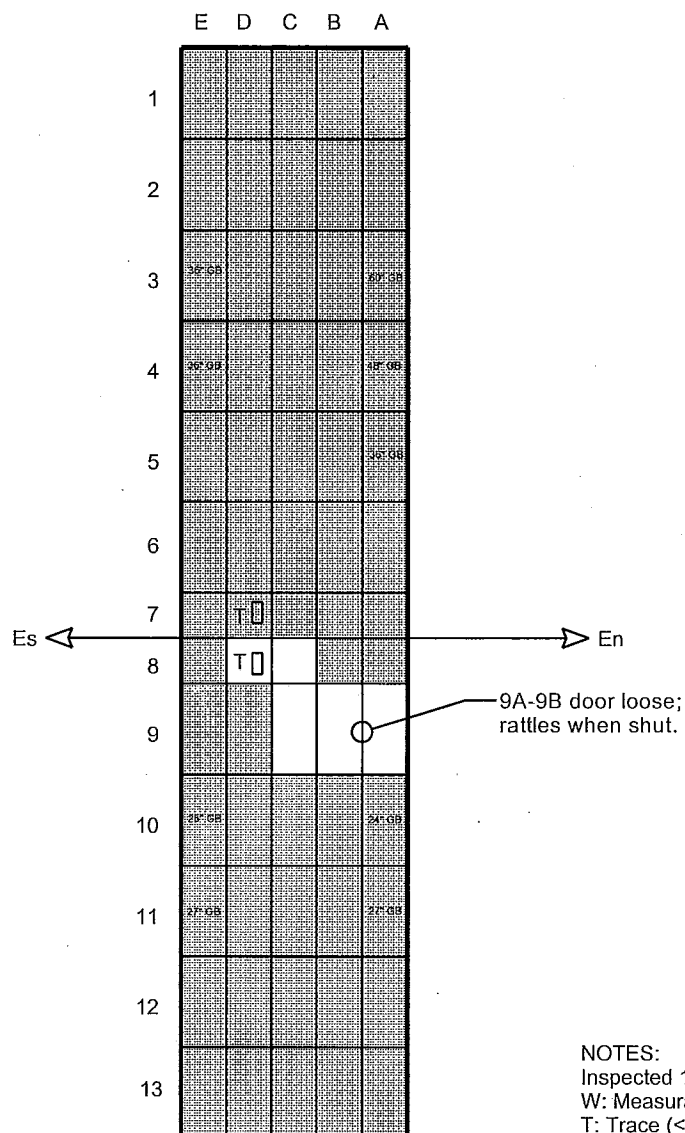
## PONTON E

<u>PONTOON</u>	<u>CELL</u>	<u>COMMENTS</u>
E	8D	Trace of Water
	9A	Door 9A-9B Loose; Rattles When Shut

- Pontoon E, Cell 9A: Repair the hatch door between cells 9A and 9B (Priority 2 REPAIR #14401).
- Pontoon F, Cell 8B: Repair the loose door handle wheel/shaft connection at interior hatch 8A-8B (Priority 2 REPAIR #14401).

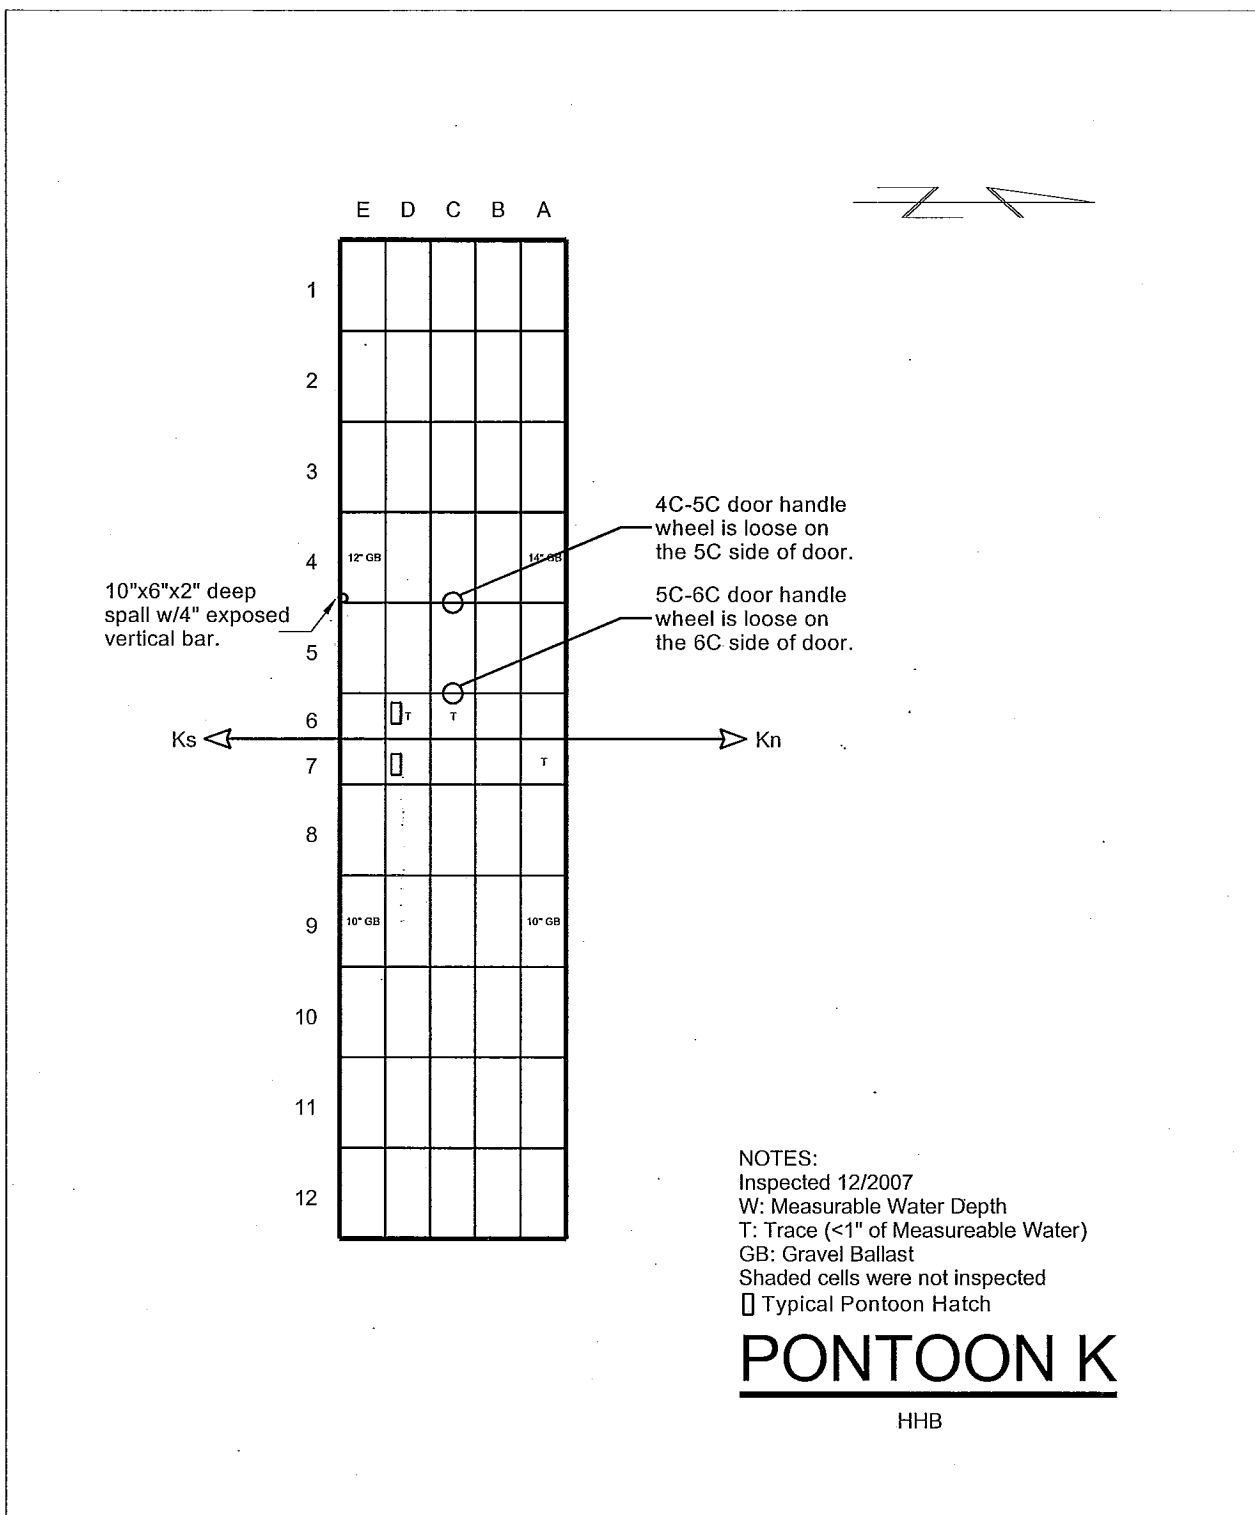
**PONTOON I**

<b><u>PONTOON</u></b>	<b><u>CELL</u></b>	<b><u>COMMENTS</u></b>
I	11E	8" of Gravel Ballast
	3D	Trace of Water
	4A	10" of Gravel Ballast
	4E	12" of Gravel Ballast
	5B	Trace of Water
	5E	Trace of Water
	6D	Trace of Water
	7D	Trace of Water
	9A	12" of Gravel Ballast
	9E	12" of Gravel Ballast
<b><u>PONTOON</u></b>	<b><u>CELL</u></b>	<b><u>COMMENTS</u></b>
K	4A	14" of Gravel Ballast
	4C	4C-5C wheel is loose on shaft
	4E	10"x6"x2" spall w/4" rebar, 12" of Gravel Ballast
	5C	5C-6C wheel is loose on shaft
	6C	Trace of water
	6D	Trace of Water
	7A	Trace of Water
	9A	10" of Gravel Ballast
	9E	10" of Gravel Ballast
<b><u>PONTOON</u></b>	<b><u>CELL</u></b>	<b><u>COMMENTS</u></b>
L	4A	12" of Gravel Ballast
	4E	10" of Gravel Ballast
	9A	12" of Gravel Ballast
	9E	12" of Gravel Ballast
	10D	Trace of Water
<b><u>PONTOON</u></b>	<b><u>CELL</u></b>	<b><u>COMMENTS</u></b>
M	4A	8" of Gravel Ballast
	4E	10" of Gravel Ballast
	6D	Trace of Water

E	D	C	B	A
1					
2					
3					
4	10" GB				12" GB
5					
6		□			
7		□			
8					
9	12" GB				12" GB
10		T			
11					
12
